DEPARTMENT OF TRANSPORTATION

Contract #: 04-0120F4Cty: SF/ALA Rte: 80 PM: 13.2/13.9File #: 69.28**WELDING INSPECTION REPORT****Resident Engineer:**Pursell, Gary**Address:** 333 Burma Road**City:** Oakland, CA 94607**Report No:** WIR-003583**Date Inspected:** 23-Jul-2008**Project Name:** SAS Superstructure**OSM Arrival Time:** 700**Prime Contractor:** American Bridge/Fluor Enterprises, a JV**OSM Departure Time:** 1500**Contractor:** Zhenhua Port Machinery Company, Ltd (ZPMC), Changxing Island **Location:** Shanghai, China**CWI Name:** Sun Wei**CWI Present:** Yes No**Inspected CWI report:** Yes No N/A**Rod Oven in Use:** Yes No N/A**Electrode to specification:** Yes No N/A**Weld Procedures Followed:** Yes No N/A**Qualified Welders:** Yes No N/A**Verified Joint Fit-up:** Yes No N/A**Approved Drawings:** Yes No N/A**Approved WPS:** Yes No N/A**Delayed / Cancelled:** Yes No N/A**Bridge No:** 34-0006**Component:** Tower and OBG**Summary of Items Observed:**

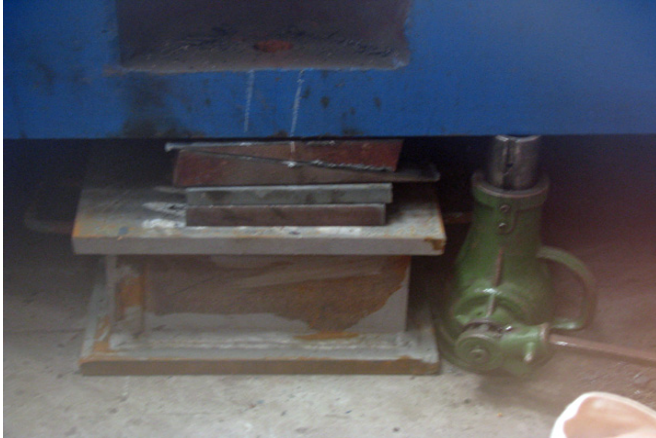
The Quality Assurance Inspector observed that ZPMC removed the South tower, Skin "A", Lift 1, sub-assembly from the cracked fabrication tables. ZPMC was in the process of jacking the tables back up and installing steel shims to act as support at the approximate center of the table. Below is a digital photograph illustrating the process.
